MEMORANDUM

SUBJECT: Site Visit – Greenleaf, L.L.C.
Neosho, Newton County, Missouri

**Photographs for Site Memo
Greenleaf, L.L.C.
Neosho and Pineville, MO**

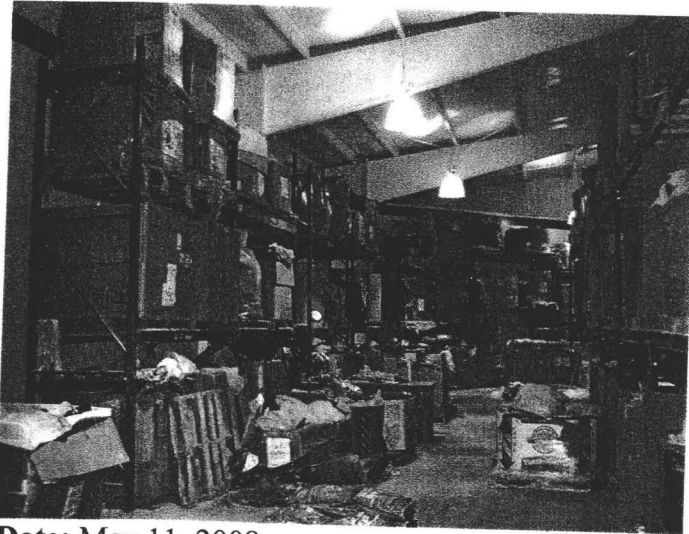
Site: Greenleaf, L.L.C., Building 1

View of the area behind the show room. Gaylord boxes are stacked three high to the ceiling. The only boxes that could be observed were the ones at eye level.

We spoke with Mr. Ralph Kunz, Plant Manager, and explained that the purpose of our visit was to evaluate Greenleaf's current compliance with hazardous waste laws and regulations. Mr. Kunz explained that he began working for Greenleaf on February 18, 2008. We walked around the showroom and the area behind the showroom of Building 1 (see photograph). It seemed to be in much better order than our last visit and there was less stored in the building. Gaylord boxes were stacked three high to the ceiling on shelving units. There was adequate aisle space to observe boxes at eye level. In multiple boxes I observed pesticide spills and the mixing of spilled pesticides. Many of the boxes contained Sevin insecticide which has the active ingredient carbaryl. I also identified canisters of Sevin that had spilled during storage and were empty. Carbaryl is a U279 listed hazardous waste. These wastes were not properly managed, labeled, or containerized as a hazardous waste. I also observed some dry spills on the floor and shelving (see photographs).

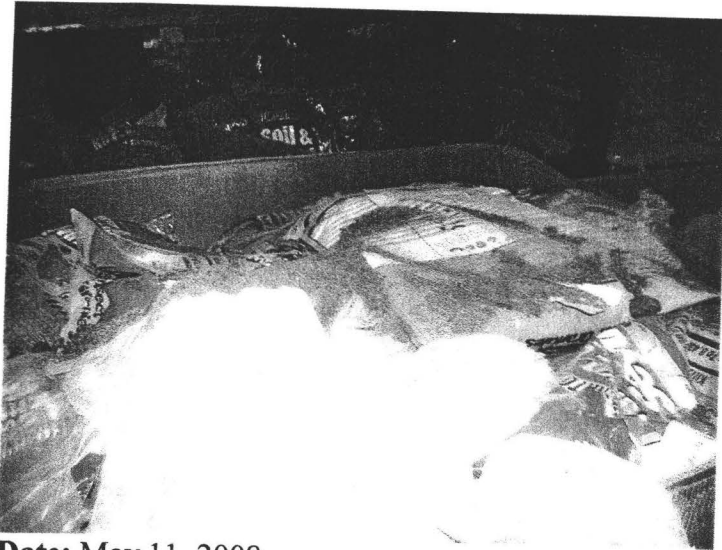
Site: Greenleaf, L.L.C., Building 1

View of spilled pesticide in Building 1.

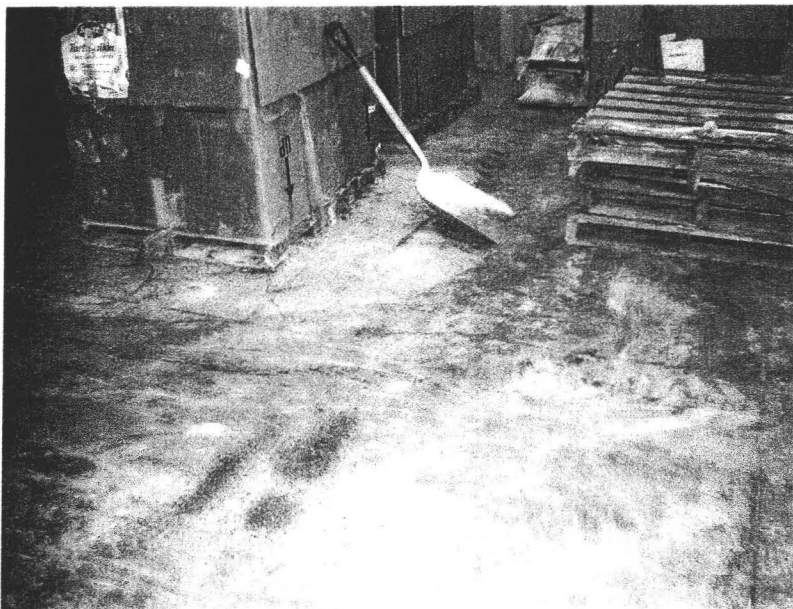
Date: May 11, 2008
Site: Greenleaf, L.L.C., Building 1
 MOR000526152 and 042018
 13960 Palm Road, Neosho, MO 64850
Photographer: Candace Bias
 View of spills on the floor of Building 1.

more than one source. Because a single specific pesticide source could not be identified for each box, prior to disposal the waste would need to be characterized by testing rather than generator knowledge. The large bins of granular material that were under the SSURO were still present; however the two fertilizer bins not under a SSURO were now empty. Spills of dry, granular material on the floor and on pallets were also common (see photographs).

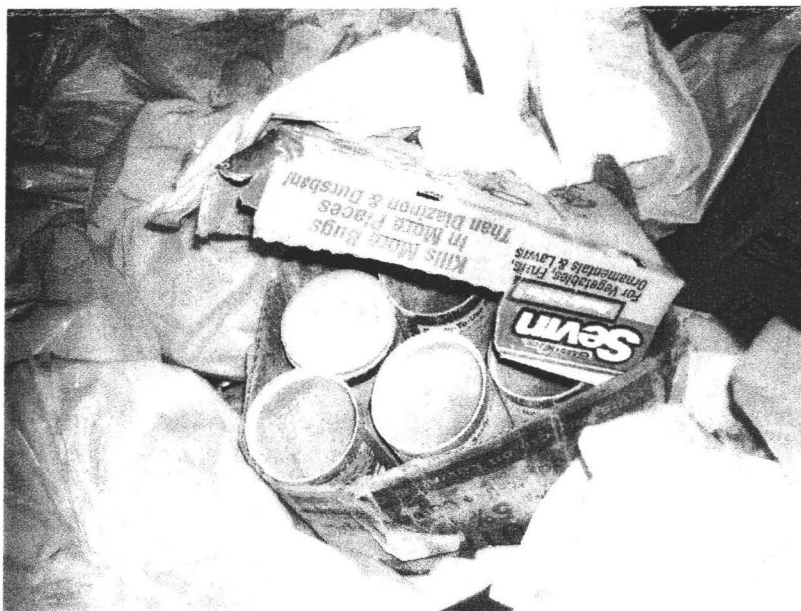
Date: May 11, 2008
Site: Greenleaf, L.L.C., Building 1
 MOR000526152 and 042018
 13960 Palm Road, Neosho, MO 64850
Photographer: Candace Bias
 View of the pesticide Sevin, containing the active ingredient carbaryl. Carbaryl is a U279 listed hazardous waste. This hazardous waste is not properly managed.

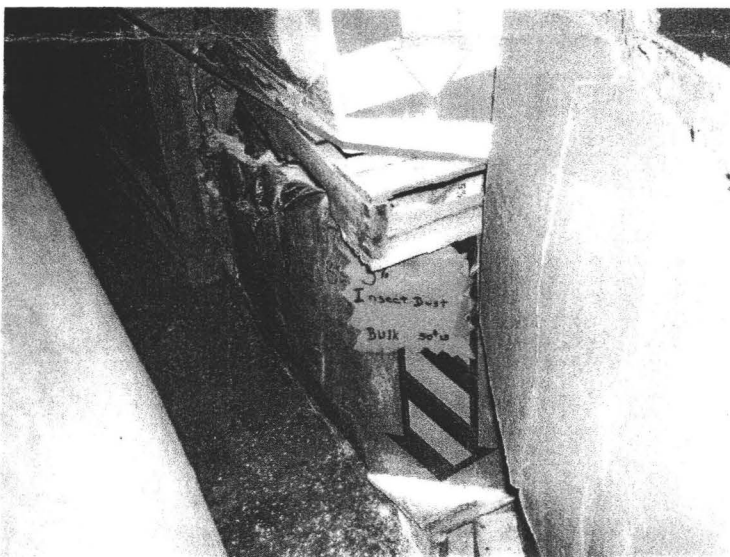
Site: Greenleaf, L.L.C., Building 1

View of Stop Sale, Use or Removal pesticides in Building 1. The dry white powder and labeling as "5% Insect Dust" is consistent with the pesticide Sevin, containing the active ingredient carbaryl. Carbaryl is a U279 listed hazardous waste. This hazardous waste is not properly managed.

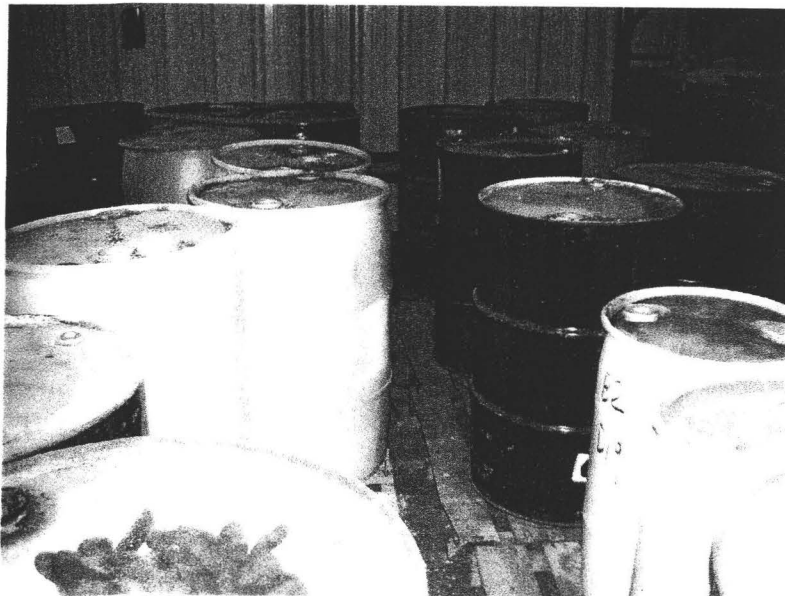
Date: May 11, 2008
Site: Greenleaf, L.L.C., Building 2
MOR000526152 and 042018
13960 Palm Road, Neosho, MO 64850
Photographer: Candace Bias
Drums of liquid in Building 2.

We then headed to Building 2. The 55-gallon drums of liquid had been moved to the northeast corner of the building. One of the drums was labeled with black marker, "Ready to Use" and another drum was labeled, "Weed Killer." I could not visually inspect every 55-gallon drum due to inadequate aisle space. There were several boxes of small liquid containers near the drums. Many of the containers appeared damaged. A few of the leaking containers had been placed in zipper type plastic bags (see photographs).

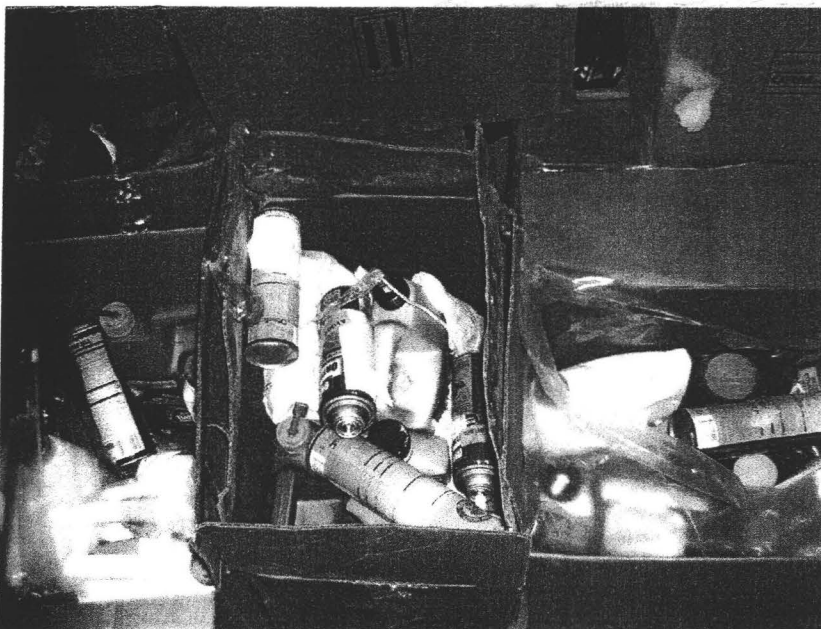
Site: Greenleaf, L.L.C., Building 2

View aerosol cans in Building 2.

Nearby there were aerosol cans in boxes along with liquid containers. I observed that many of the aerosol cans were missing their spray caps or felt empty (see photographs). Mr. Kunz informed us that more liquid containers had been stored outside in a trailer. I then walked through the rest of Building 2. The west side of the building was packed and did not have adequate aisle space to do a proper inspection. Most of the items on the west side of the building appeared to be dry, bagged pesticides. Spills had not been cleaned up (see photographs). Along the west wall of Building 2 I observed three Gaylord boxes that had been spray painted with the words "FREE PEST" (see photograph). It was evident that the boxes had been labeled by Greenleaf because similar writing appeared on boxes in Building 1 placed under the SSURO. Mr. Kunz did not know why they had been labeled that way.

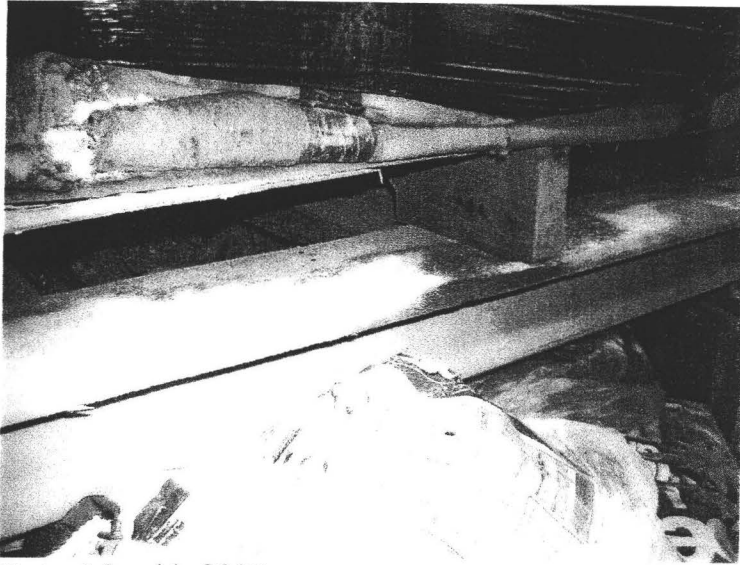
Site: Greenleaf, L.L.C., Building 2

View of dry spill on west side of Building 2. The dry white powder next to a bag of Sevin is likely Sevin pesticide, which is a listed hazardous waste when disposed.

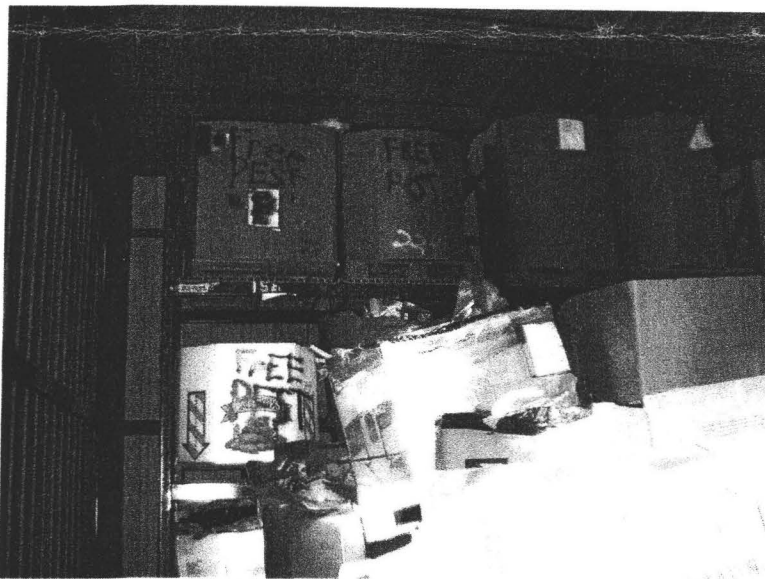
Site: Greenleaf, L.L.C., Building 2

View of boxes labeled "Free Pest" on the west side of Building 2. Note the inadequate aisle space.

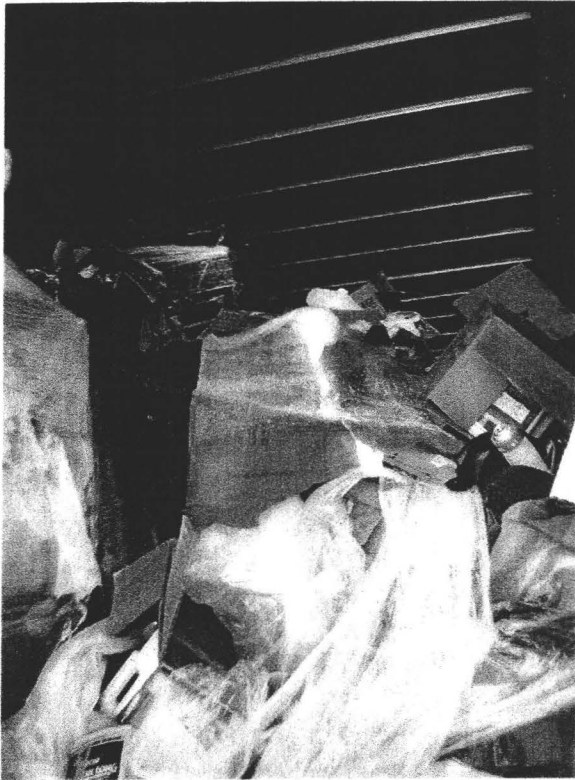
View of trailer in parking lot that contains pesticides removed from Building 2.

Finally, we looked at the items stored in the storage trailer. The boxes were in disarray and there was no aisle space (see photograph). We did not enter the trailer and were unable to visually observe its contents. Mr. Kunz told us that they had moved these items into the trailer to relieve some of the congestion in Building 2.

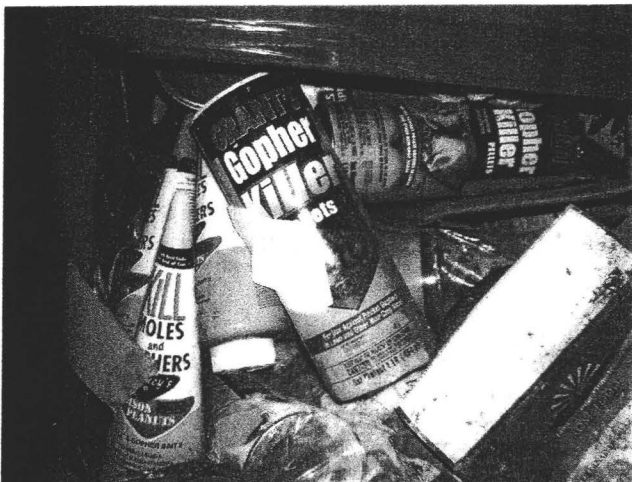
View of Sweeney's Poison Peanuts Mole and Gopher Bait and Grant's Sure Stop Gopher Killer Pellets. Both pesticides contain the active ingredient zinc phosphide, a U249 listed hazardous waste at this concentration. This hazardous waste is not properly managed. Zinc phosphide can also produce gas that is dangerous to humans if it becomes wet.

Next we entered the operations area of the warehouse. A strong smell of ammonia was emanating from the southwest corner of the building. Mr. Applegarth speculated that the smell was the result of fertilizer getting wet. He told us that the MDA inspectors had informed him that one of the pesticides for killing moles would produce a hazardous gas if it became wet. I identified two pesticides that had zinc phosphide as the sole active ingredient, *Sweeney's Poison Peanuts Mole and Gopher Bait* and *Grant's Sure Stop Gopher Killer Pellets* (see photograph). Zinc phosphide is a U249 listed hazardous waste. These wastes were not properly managed, labeled, or containerized as a hazardous waste.

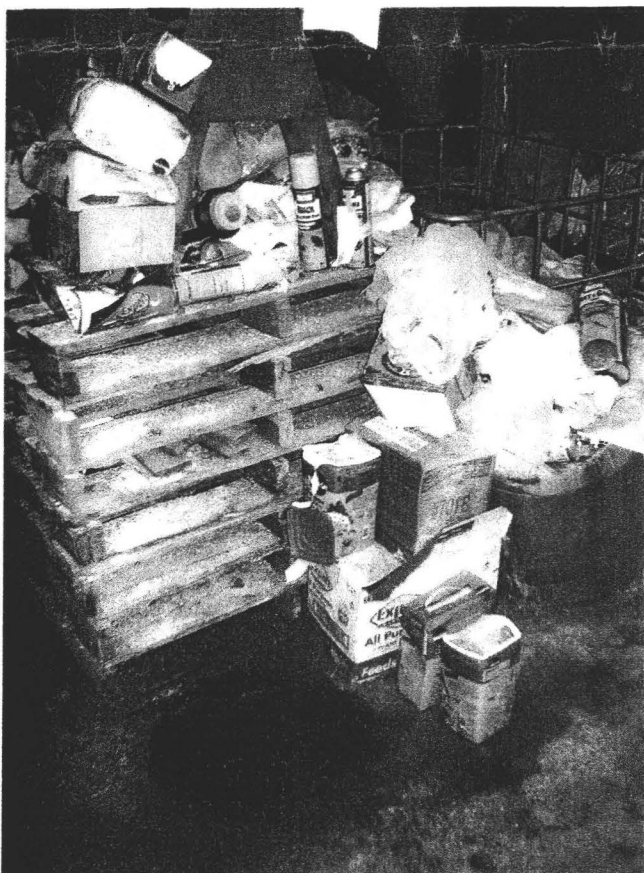
View of spills.

Employees in the warehouse were sorting the contents of Gaylord boxes. The warehouse appeared to be loosely organized, with pesticides haphazardly segregated in the southwest corner of the building. Spilled materials were everywhere (see photographs). Boxes and their contents were in poor, deteriorated condition due to previous exposure to the outside elements (see photographs).

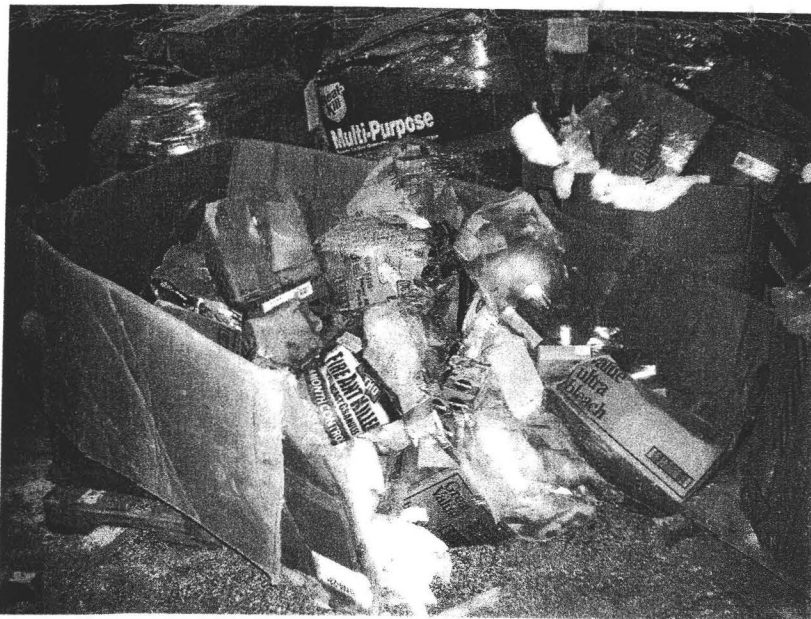
View of spills and mixing of pesticides in boxes.

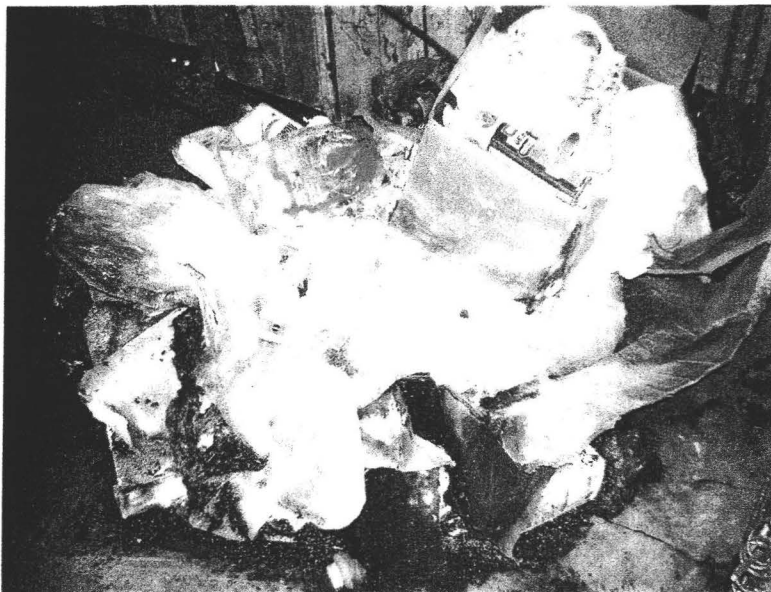
View of spills and box in poor condition due to exposure to the elements.

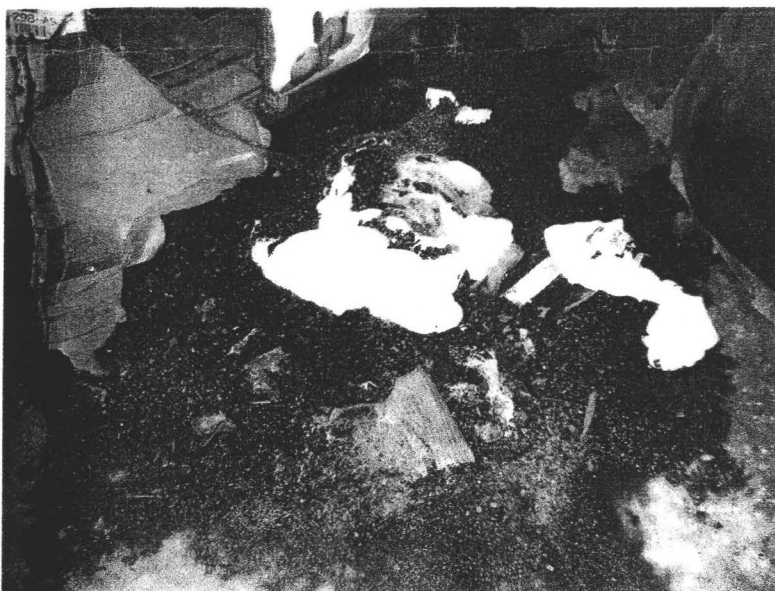
View of spills and box in poor condition due to exposure to the elements.

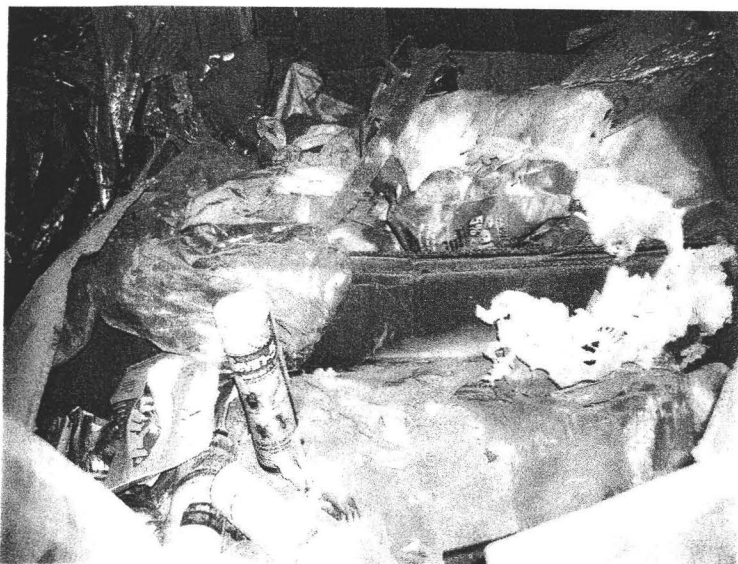
View of the pesticide Sevin, containing the active ingredient carbaryl. Carbaryl is a U279 listed hazardous waste. This hazardous waste is not properly managed.

At several locations, I identified dry *Garden Tech's Sevin-5* in both the bag and canister (see photographs). Sevin is a pesticide that contains carbaryl as the sole active ingredient. Carbaryl is a listed hazardous waste. These wastes were not properly managed, labeled, or containerized as a hazardous waste.

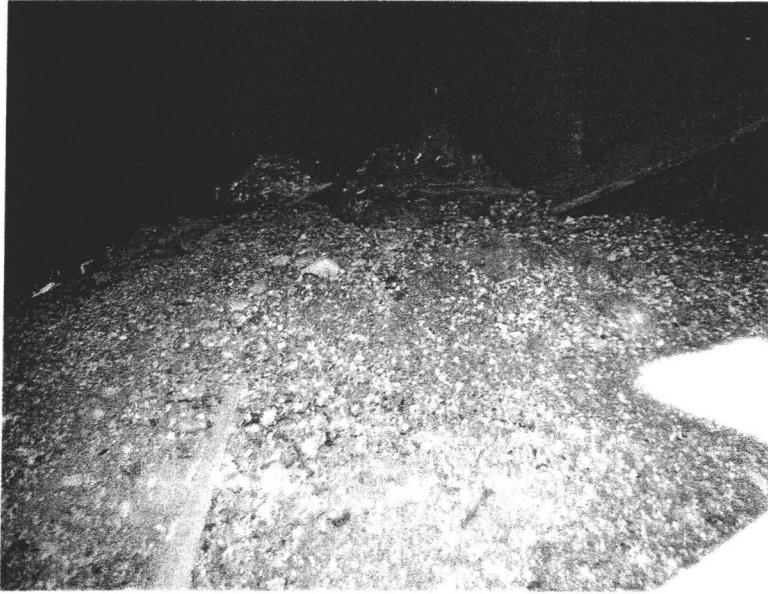
View of floor sweepings.

Mr. Applegarth told us that employees sweep all floor sweepings into large super sacks. He estimated that they have four or five super sacks with floor sweepings already. The floor sweepings that I observed were not homogeneous and appeared to be from multiple sources (see photograph).
